Local Asbestos Management Plan (LAMP) and Asbestos Register

01436 - Pinewood Infant and Nursery

Site address: Pinewood Avenue Arnold Nottingham Nottinghamshire NG5 8BU

Report Date: 13/10/2025

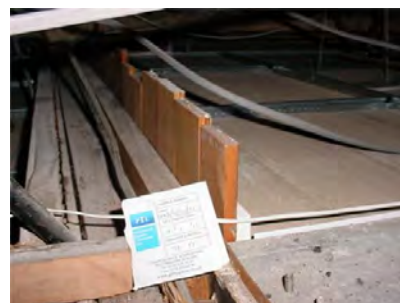
Ref	Status	Sample No.	Location	Extent	Type	Material score	Material risk	Priority	Overall risk	Resurvey date
108	Presumed	01436-01-01-P01	01 00 Teaching Block 001 CirculationGround :	3 SQUARE METRES	Chrysotile	8	C	3	Low	19/09/2026

Debris within the partition wall cavity adjoining Room 32 presumed to contain asbestos.

- Restrict Access

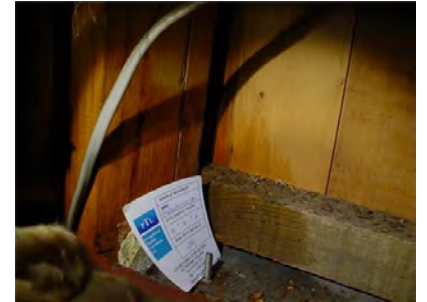
Ref	Status	Sample No.	Location	Extent	Type	Material score	Material risk	Priority	Overall risk	Resurvey date
95	Tested Positive	01436-01-02-01	01 00 Teaching Block 002 CirculationGround : CEILING VOID	1 LINEAR METRE	Chrysotile	8	C	5	Low	19/09/2026

AIB packers to pipe boxing.

- Restrict Access

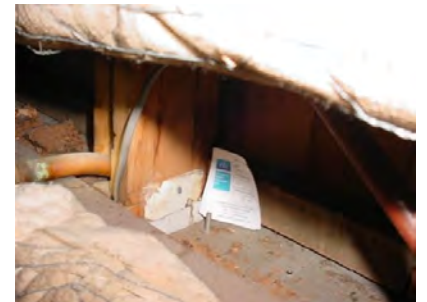
Ref	Status	Sample No.	Location	Extent	Type	Material score	Material risk	Priority	Overall risk	Resurvey date
100	Tested Positive	01436-01-02-02	01 00 Teaching Block 002 CirculationGround : CEILING VOID	< 1 SQUARE METRE	Chrysotile	7	C	3	Low	19/09/2026

AIB packer to timber boxing housing the heating pipework to Room 14.

- Restrict Access

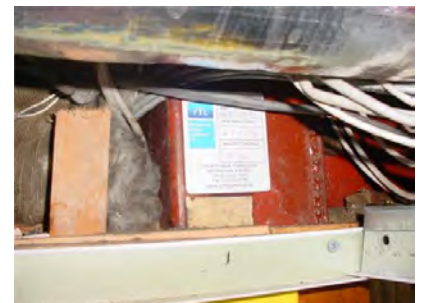
Ref	Status	Sample No.	Location	Extent	Type	Material score	Material risk	Priority	Overall risk	Resurvey date
104	Tested Positive	01436-01-02-02A	01 00 Teaching Block 002 CirculationGround :	3 LIN METRES	Chrysotile	4	B	5	Low	19/09/2026

CEMENT PACKERS WITHIN CEILING VOID

- Restrict Access

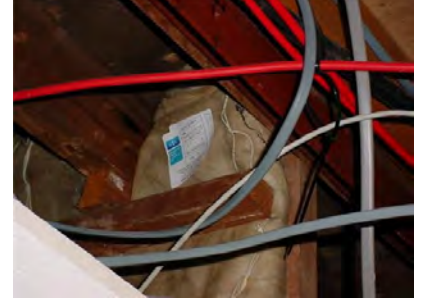
Ref	Status	Sample No.	Location	Extent	Type	Material score	Material risk	Priority	Overall risk	Resurvey date
102	Tested Positive	01436-01-02-03	01 00 Teaching Block 002 CirculationGround : CEILING VOID	15 LINEAR METRES	Chrysotile	6	B	7	Low	19/09/2026

Glass fibre fire break rope reinforcing to Rooms 28, 29, 332 & Room 1 of Building 50 within the ceiling void.

- Restrict Access

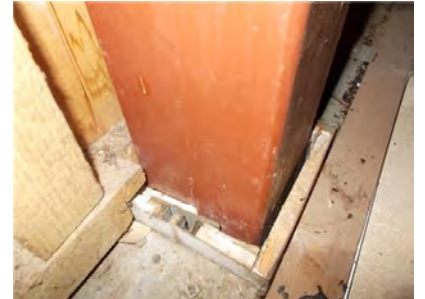
Ref	Status	Sample No.	Location	Extent	Type	Material score	Material risk	Priority	Overall risk	Resurvey date
124	Tested Positive	01436-01-02-05A	01 00 Teaching Block 002 CirculationGround :	<1m2	Amphibole ex. Crocidolite	5	B	5	Low	19/09/2026

Packer to column adjacent doors to main hall - Viewed from ceiling void

- Restrict Access

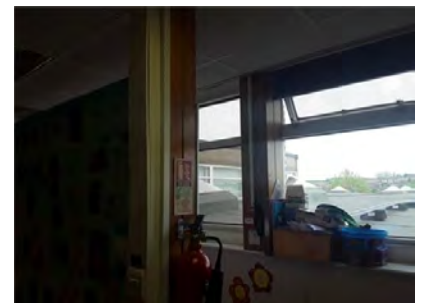
Ref	Status	Sample No.	Location	Extent	Type	Material score	Material risk	Priority	Overall risk	Resurvey date
185	Presumed	01436-01-02-P01	01 00 Teaching Block 002 CirculationGround :	6lm	Crocidolite	7	C	4	Low	19/09/2026

Presumed asbestos insulating board packers to columns at each side of upper level of stairs.

- Restrict Access

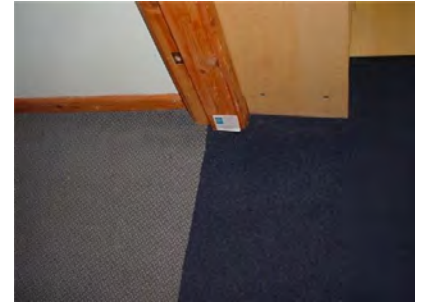
Ref	Status	Sample No.	Location	Extent	Type	Material score	Material risk	Priority	Overall risk	Resurvey date
98	Presumed	01436-01-02-P08	01 00 Teaching Block 002 CirculationGround :	20 SQUARE METRES	Chrysotile	3	A	6	Low	19/09/2026

Bitumen adhesive below the carpet.

- Monitor & Manage

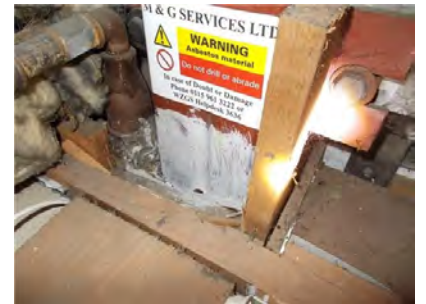
Ref	Status	Sample No.	Location	Extent	Type	Material score	Material risk	Priority	Overall risk	Resurvey date
130	Tested Positive	01436-01-04-01	01 00 Teaching Block 004 ClassroomGround :	2.5m	Amphibole ex. Crocidolite	6	B	2	Very Low	19/09/2026

Lining to column adjacent entry door to stairs - Viewed from within ceiling void

- Restrict Access

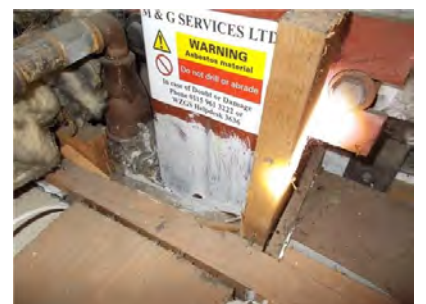
Ref	Status	Sample No.	Location	Extent	Type	Material score	Material risk	Priority	Overall risk	Resurvey date
131	Presumed	01436-01-04-SP02	01 00 Teaching Block 004 ClassroomGround :	2.5	Amphibole ex. Crocidolite	6	B	2	Very Low	19/09/2026

Lining to column adjacent entry door to stairs - Viewed from within ceiling void

- Restrict Access

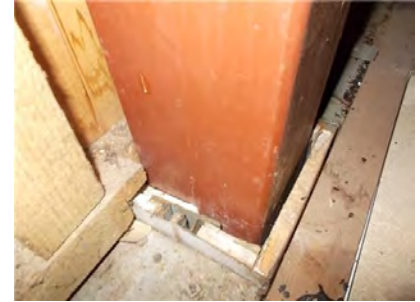
Ref	Status	Sample No.	Location	Extent	Type	Material score	Material risk	Priority	Overall risk	Resurvey date
135	Presumed	01436-01-14-SP03	01 00 Teaching Block 014 HallGround :	<1m2	Amphibole ex. Crocidolite	5	B	5	Low	19/09/2026

Packer to column adjacent doors from Reception Lobby - Viewed from ceiling void

- Restrict Access

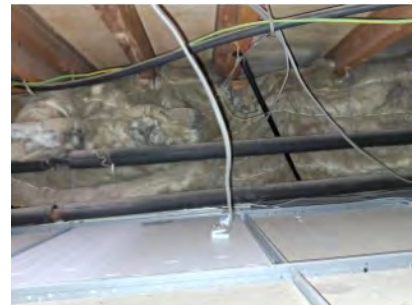
Ref	Status	Sample No.	Location	Extent	Type	Material score	Material risk	Priority	Overall risk	Resurvey date
194	Tested Positive	01436-01-25-01	01 00 Teaching Block 025 WCGround :		Chrysotile	8	C	4	Low	19/09/2026

Woven string to fibreglass firebreaks some behind plasterboard firebreaks.

- Restrict Access

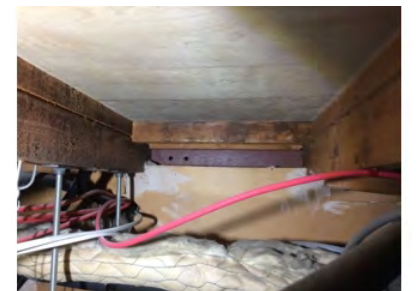
Ref	Status	Sample No.	Location	Extent	Type	Material score	Material risk	Priority	Overall risk	Resurvey date
186	Tested Positive	01436-01-26-05	01 00 Teaching Block 026 KitchenGround :	2 Lin M	Chrysotile	5	B	5	Low	19/09/2026

String within MMMF firebreak behind plasterboard in ceiling void to 2 Kitchen Store, Building 50.

- Restrict Access

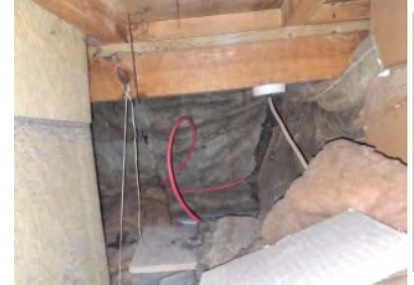
Ref	Status	Sample No.	Location	Extent	Type	Material score	Material risk	Priority	Overall risk	Resurvey date
200	Presumed	01436-01-28-SP01	01 00 Teaching Block 028 Staff WC Ground :	6m2	Chrysotile	8	C	4	Low	19/09/2026

Woven string to fibreglass firebreaks some behind plasterboard firebreaks.

- Restrict Access

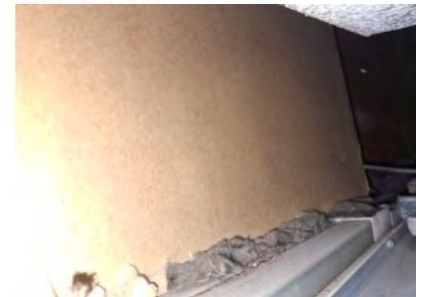
Ref	Status	Sample No.	Location	Extent	Type	Material score	Material risk	Priority	Overall risk	Resurvey date
201	Presumed	01436-01-29-SP01	01 00 Teaching Block 029 Staff WC Ground :	6m2	Chrysotile	8	C	4	Low	19/09/2026

Woven string to fibreglass firebreaks some behind plasterboard firebreaks.

- Restrict Access

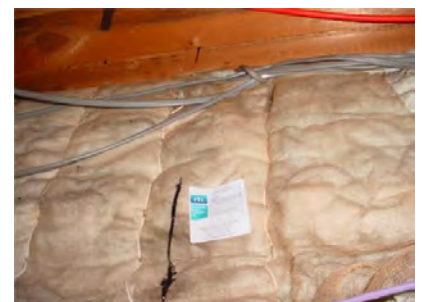
Ref	Status	Sample No.	Location	Extent	Type	Material score	Material risk	Priority	Overall risk	Resurvey date
86	Tested Positive	01436-01-30-10	01 00 Teaching Block 030 StorageGround : CEILING VOID	3 LINEAR METRES	Chrysotile	7	C	6	Low	19/09/2026

Rope textile to the fire break within the ceiling void.

- Restrict Access

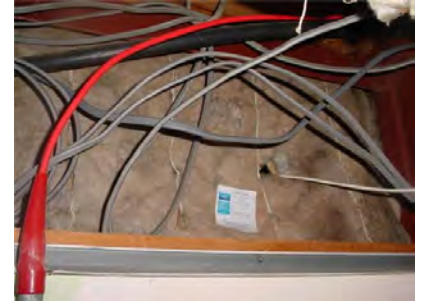
Ref	Status	Sample No.	Location	Extent	Type	Material score	Material risk	Priority	Overall risk	Resurvey date
78	Tested Positive	01436-01-33-06	01 00 Teaching Block 032 OfficeGround : CEILING VOID	3 SQUARE METRES	Chrysotile	7	C	3	Low	19/09/2026

Textile rope to fire break within the Ceiling Void. Limited access gained within the wall cavities. Monitor & Manage Textile Rope. Restrict access within the wall cavities.

- Restrict Access

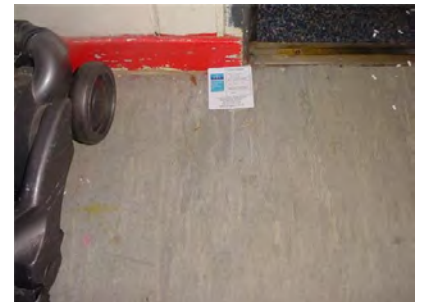
Ref	Status	Sample No.	Location	Extent	Type	Material score	Material risk	Priority	Overall risk	Resurvey date
79	Tested Positive	01436-01-33-07	01 00 Teaching Block 032 OfficeGround :	6 SQUARE METRES	Chrysotile	3	A	5	Very Low	19/09/2026

Bitumen adhesive below the modern vinyl. Restrict access within the wall cavities.

- Monitor & Manage

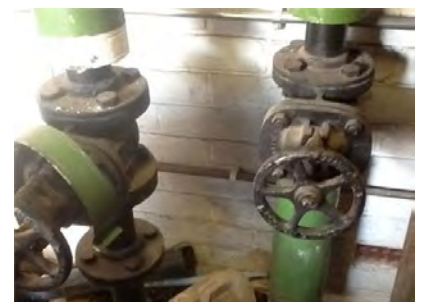
Ref	Status	Sample No.	Location	Extent	Type	Material score	Material risk	Priority	Overall risk	Resurvey date
171	Tested Positive	01436-01-38-23	01 00 Teaching Block 038 Boiler RoomGround :	<1m2	Chrysotile	5	B	5	Low	19/09/2026

Gaskets to pipework joints. Some of the pipework has been replaced.

- Monitor & Manage

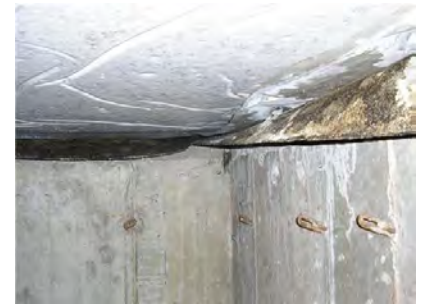
Ref	Status	Sample No.	Location	Extent	Type	Material score	Material risk	Priority	Overall risk	Resurvey date
65	Tested Positive	01436-01-40-09	01 00 Teaching Block 040 StorageBasement :	50 LIN M	Chrysotile	3	A	2	Very Low	19/09/2026

BASEMENT STORE CEILING. No key available

- Restrict Access

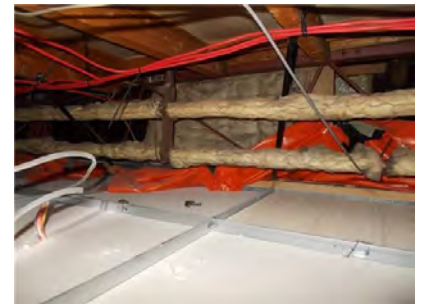
Ref	Status	Sample No.	Location	Extent	Type	Material score	Material risk	Priority	Overall risk	Resurvey date
157	Presumed	01436-50-01-P05	50 00 Catering Services 001 KitchenGround :	N/Q	Amphibole ex. Crocidolite	7	C	3	Low	19/09/2026

Former enclosure visqueen material present in ceiling void to adjacent toilet and cleaners areas

- Restrict Access

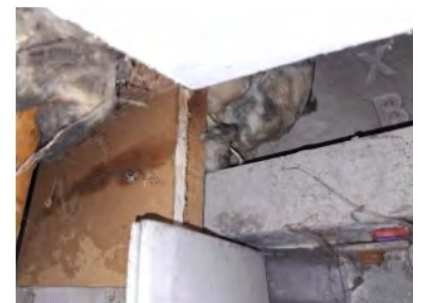
Ref	Status	Sample No.	Location	Extent	Type	Material score	Material risk	Priority	Overall risk	Resurvey date
196	Tested Positive	01436-50-02-05	50 00 Catering Services 002 KitchenGround :	4m2	Chrysotile	6	B	4	Low	19/09/2026

Woven to fibreglass firebreaks behind plasterboard to external wall.

- Restrict Access
