Local Asbestos Management Plan (LAMP) and Asbestos Register

01436 - Pinewood Infant and Nursery

Site address: Pinewood Avenue Arnold Nottingham Nottinghamshire NG5 8BU

Report Date: 13/10/2025

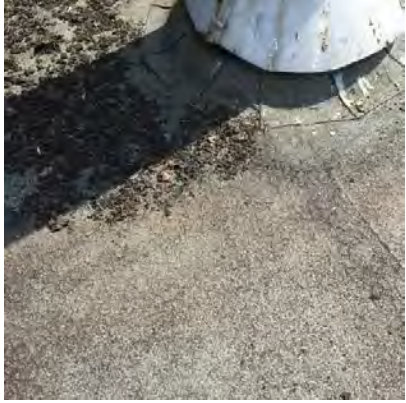
Ref	Status	Sample No.	Location
176	Tested Negative	01436-01-00-02	01 00 Teaching Block 000 External/FixturesGround :
Description Felt Notes Felt to flat roof above Boiler Room. Accessed during survey Yes

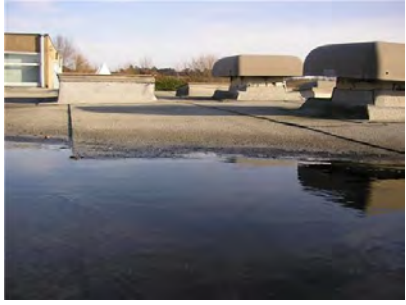
Ref	Status	Sample No.	Location
111	Tested Negative	01436-01-00-08	01 00 Teaching Block 000 External/FixturesGround :
Description Notes EXTERIOR ROOF Accessed during survey Yes

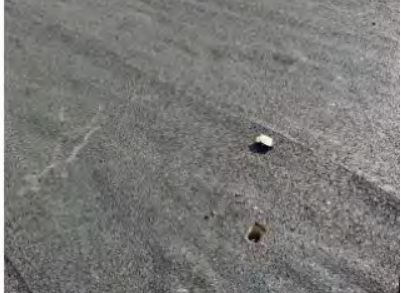
Ref	Status	Sample No.	Location
198	Tested Negative	01436-01-00-09	01 00 Teaching Block 000 External/FixturesGround :
Description Felt Notes Felt to timber roof deck below roof felt and kingspan insulation to high level roof Accessed during survey Yes

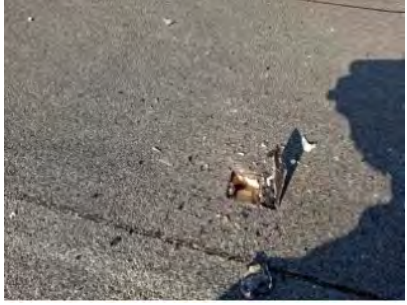
Ref	Status	Sample No.	Location
199	Tested Negative	01436-01-00-10	01 00 Teaching Block 000 External/FixturesGround :
Description Felt

Notes Felt to timber roof deck below roof felt and kingspan insulation to low level roof			
Accessed during survey Yes

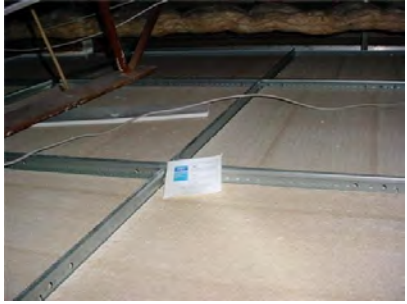
Ref	Status	Sample No.	Location
105	Tested Negative	01436-01-01-13	01 00 Teaching Block 001 CirculationGround : CEILING VOID
Description

Notes Insulation board debris on top of ceiling tiles.			
Accessed during survey Yes

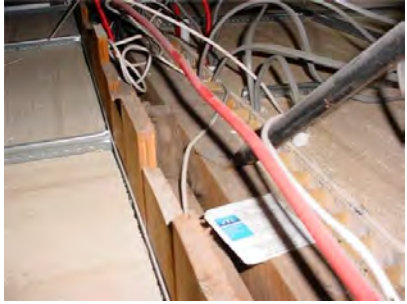
Ref	Status	Sample No.	Location
106	Tested Negative	01436-01-01-14	01 00 Teaching Block 001 CirculationGround : CEILING VOID
Description

Notes Insulation board debris on top of the wall within the ceiling void.			
Accessed during survey Yes

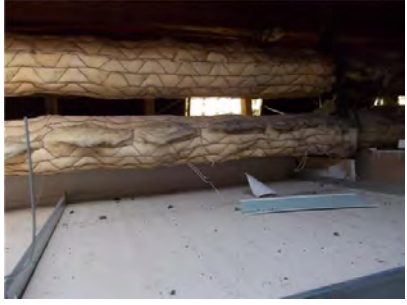
Ref	Status	Sample No.	Location
126	Tested Negative	01436-01-02-07	01 00 Teaching Block 002 CirculationGround :
Description String to pipework running into room 15

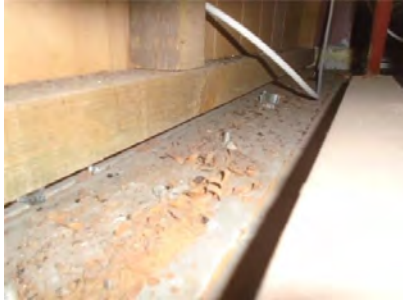
Ref	Status	Sample No.	Location
181	Tested Negative	01436-01-02-10	01 00 Teaching Block 002 CirculationGround :
Description Notes Non asbestos debris in ceiling void. Accessed during survey Yes

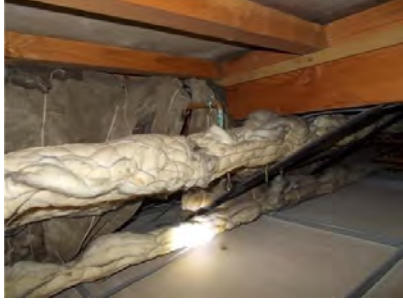
Ref	Status	Sample No.	Location
132	Tested Negative	01436-01-06-01	01 00 Teaching Block 004 ClassroomGround :
Description Notes String to pipework and firebreak within ceiling void Accessed during survey Yes

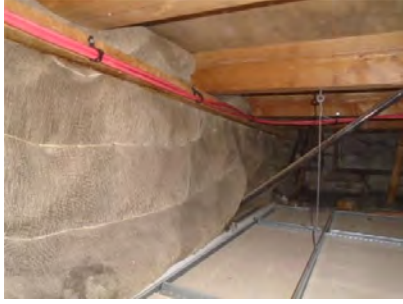
Ref	Status	Sample No.	Location
183	Tested Negative	01436-01-12-01	01 00 Teaching Block 012 CloakroomGround :
Description Notes Non asbestos textile to mmmf firebreak in ceiling void. Accessed during survey Yes

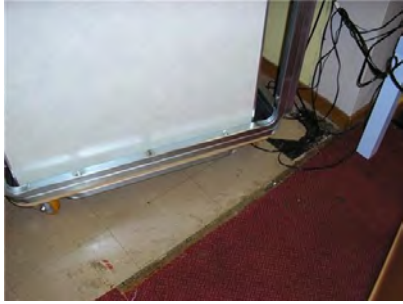
Ref	Status	Sample No.	Location
91	Tested Negative	01436-01-14-02	01 00 Teaching Block 014 HallGround : HALL
Description Accessed during survey Yes

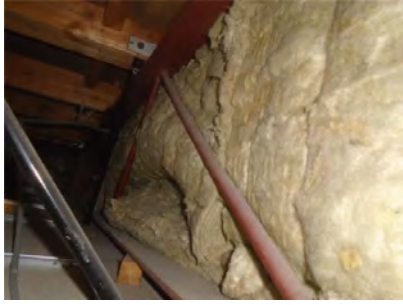
Ref	Status	Sample No.	Location
180	Tested Negative	01436-01-15-01	01 00 Teaching Block 015 Staff KitchenGround :
Description Notes Non asbestos mmmf firebreak in ceiling void. Accessed during survey Yes

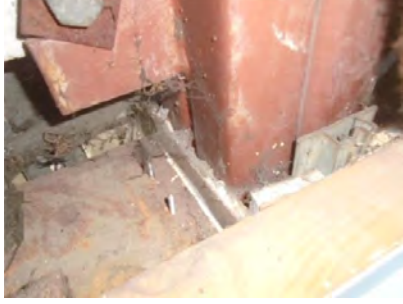
Ref	Status	Sample No.	Location
182	Tested Negative	01436-01-23-01	01 00 Teaching Block 023 ClassroomGround :
Description Notes Non asbestos debris adjacent to plasterboard column lining in ceiling void. Accessed during survey Yes

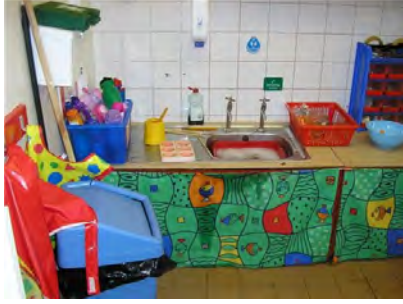
Ref	Status	Sample No.	Location
90	Tested Negative	01436-01-23-05	01 00 Teaching Block 023 ClassroomGround : NURSERY
Description Accessed during survey Yes

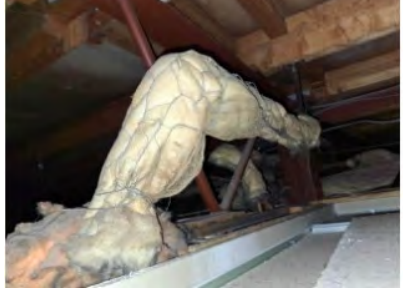
Ref	Status	Sample No.	Location
193	Tested Negative	01436-01-24-01	01 00 Teaching Block 024 ResourcesGround :
Description Woven Textile Notes Woven string to fibreglass insulation to pipework within ceiling void. Accessed during survey Yes

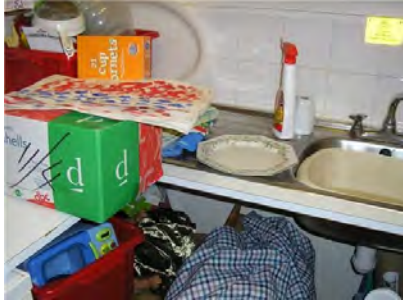
Ref	Status	Sample No.	Location
87	Tested Negative	01436-01-26-03	01 00 Teaching Block 026 KitchenGround : KITCHENETTE
<p>Description</p> <p>Accessed during survey Yes</p>

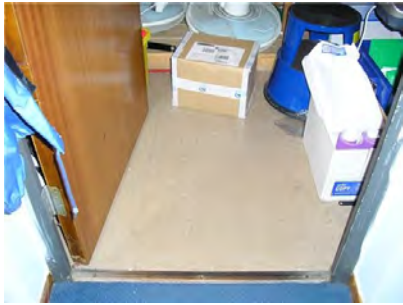
Ref	Status	Sample No.	Location
84	Tested Negative	01436-01-31-01	01 00 Teaching Block 032 OfficeGround : STORE ROOM
<p>Description</p> <p>Accessed during survey Yes</p>

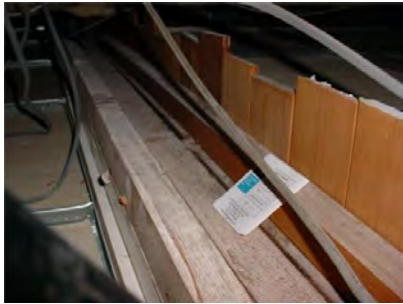
Ref	Status	Sample No.	Location
83	Tested Negative	01436-01-33-15	01 00 Teaching Block 032 OfficeGround : CEILING VOID
<p>Description</p> <p>Notes Insulation board debris to the top of the wall within the ceiling void.</p> <p>Accessed during survey Yes</p>

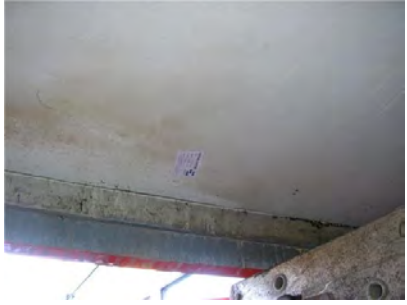
Ref	Status	Sample No.	Location
76	Tested Negative	01436-01-35-06	01 00 Teaching Block 035 StorageGround : STORE CEILING
Description Notes EuroEnvironmental Survey and Acorn PRN18736R3 state this ceiling is Negative. Accessed during survey Yes

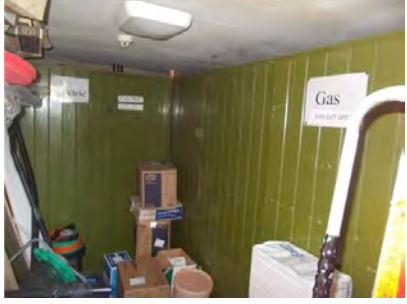
Ref	Status	Sample No.	Location
146	Tested Negative	01436-01-36-01	01 00 Teaching Block 036 MeterGround :
Description Lining to ceiling Accessed during survey Yes

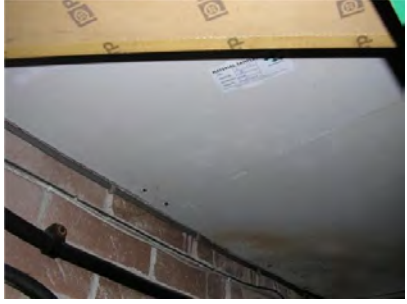
Ref	Status	Sample No.	Location
74	Tested Negative	01436-01-36-07	01 00 Teaching Block 036 MeterGround : ELECTRIC ROOM CEILING
Description Accessed during survey Yes

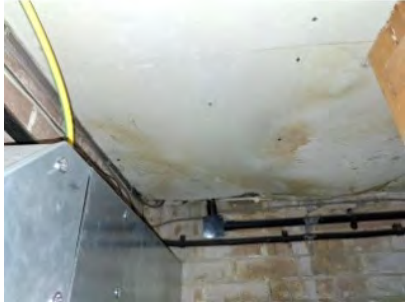
Ref	Status	Sample No.	Location
197	Tested Negative	01436-01-36-08	01 00 Teaching Block 036 MeterGround :
Description Insulating Board Notes Insulating board ceiling. Accessed during survey Yes

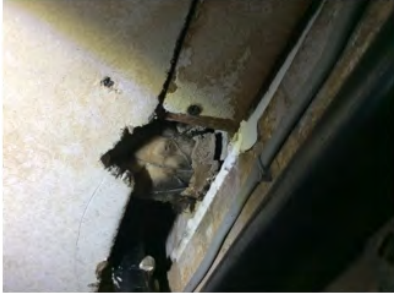
Ref	Status	Sample No.	Location
190	Tested Negative	01436-01-37-01	01 00 Teaching Block 037 MeterGround :
Description Rope & String

Notes String wrap to fiberglass insulation on pipework in ceiling void over rooms 35, 36 and 37			
Accessed during survey Yes

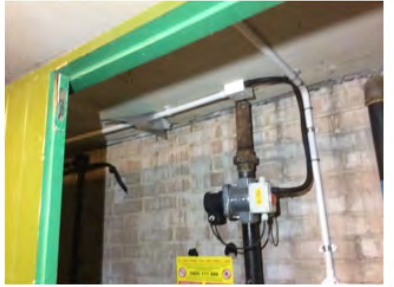
Ref	Status	Sample No.	Location
191	Tested Negative	01436-01-37-02	01 00 Teaching Block 037 MeterGround :
Description Insulating Board

Notes Same insulating board ceiling over rooms 35, 36 and 37			
Accessed during survey Yes

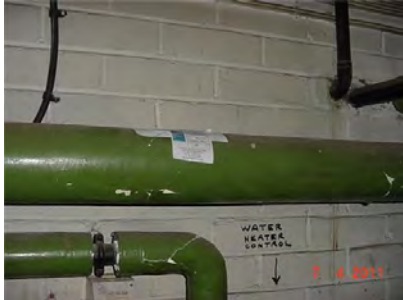
Ref	Status	Sample No.	Location
73	Tested Negative	01436-01-38-03	01 00 Teaching Block 038 Boiler RoomGround :
Description

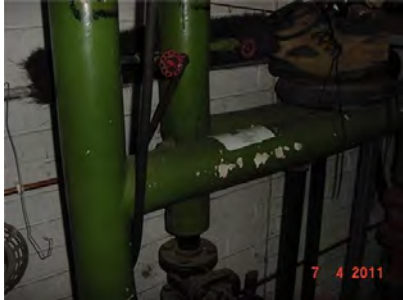
Ref	Status	Sample No.	Location
66	Tested Negative	01436-01-38-05	01 00 Teaching Block 038 Boiler RoomGround :
Description

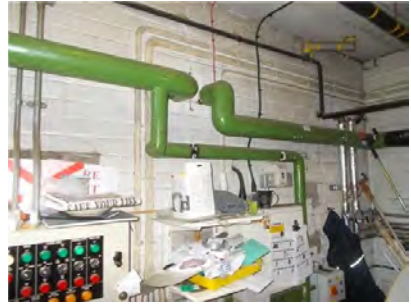
Ref	Status	Sample No.	Location
112	Tested Negative	01436-01-38-12	01 00 Teaching Block 038 Boiler RoomGround :
Description Notes Hard set insulation to pipework over fibreglass inner lining. Accessed during survey Yes

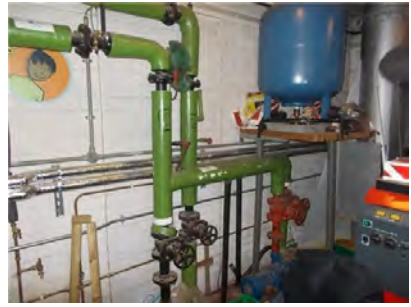
Ref	Status	Sample No.	Location
113	Tested Negative	01436-01-38-13	01 00 Teaching Block 038 Boiler RoomGround :
Description Notes Hard set insulation to pipework over fibreglass inner lining Accessed during survey Yes

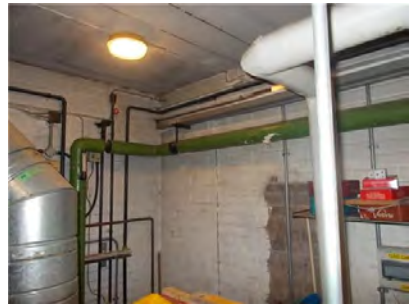
Ref	Status	Sample No.	Location
114	Tested Negative	01436-01-38-14	01 00 Teaching Block 038 Boiler RoomGround :
Description Notes Hard set insulation to pipework over fibreglass inner lining Accessed during survey Yes

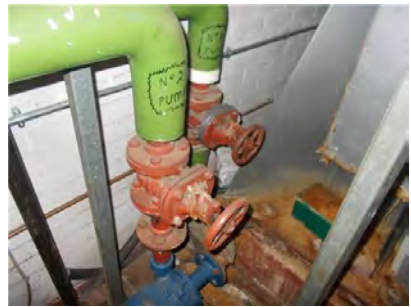
Ref	Status	Sample No.	Location
115	Tested Negative	01436-01-38-15	01 00 Teaching Block 038 Boiler RoomGround :
Description Notes Joint seals to pipework, presumed throughout Accessed during survey Yes

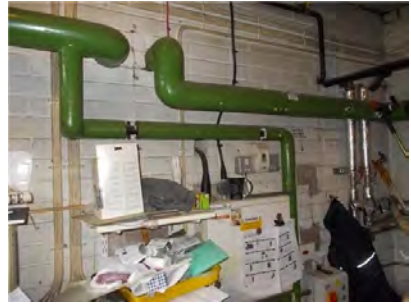
Ref	Status	Sample No.	Location
116	Tested Negative	01436-01-38-16	01 00 Teaching Block 038 Boiler RoomGround :
<p>Description</p> <p>Notes Debris to walls behind pipework throughout</p> <p>Accessed during survey Yes</p>

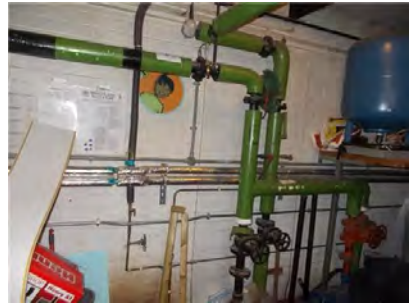
Ref	Status	Sample No.	Location
117	Tested Negative	01436-01-38-17	01 00 Teaching Block 038 Boiler RoomGround :
<p>Description</p> <p>Notes Debris to walls behind pipework throughout</p> <p>Accessed during survey Yes</p>

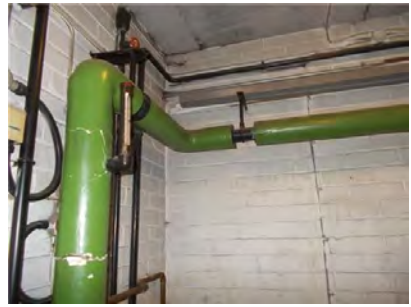
Ref	Status	Sample No.	Location
118	Tested Negative	01436-01-38-18	01 00 Teaching Block 038 Boiler RoomGround :
<p>Description</p> <p>Notes Debris to walls behind pipework throughout</p> <p>Accessed during survey Yes</p>

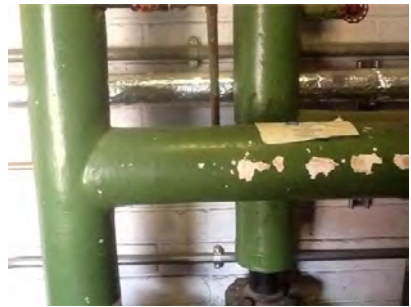
Ref	Status	Sample No.	Location
170	Tested Negative	01436-01-38-22	01 00 Teaching Block 038 Boiler RoomGround :
<p>Description Thermal Insulation</p> <p>Notes Insulation to pipework (green).</p> <p>Accessed during survey Yes</p>

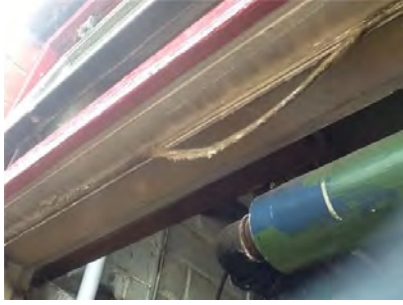
Ref	Status	Sample No.	Location
172	Tested Negative	01436-01-38-24	01 00 Teaching Block 038 Boiler RoomGround :
Description Woven Textile

Notes Woven seal to door surround.			
Accessed during survey Yes

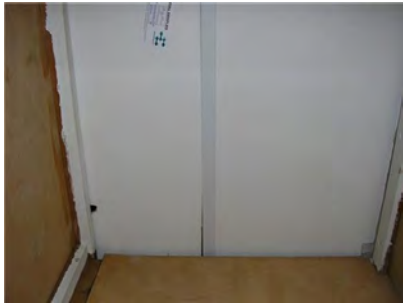
Ref	Status	Sample No.	Location
62	Tested Negative	01436-50-01-02	50 00 Catering Services 001 KitchenGround : AIRING CUPBOARD
Description

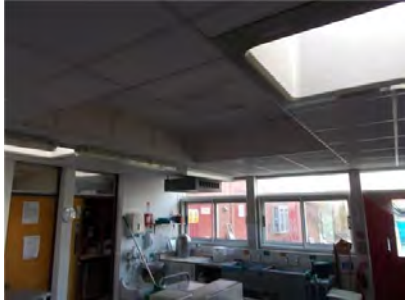
Ref	Status	Sample No.	Location
155	Tested Negative	01436-50-01-03	50 00 Catering Services 001 KitchenGround :
Description Ceiling tiles Accessed during survey Yes

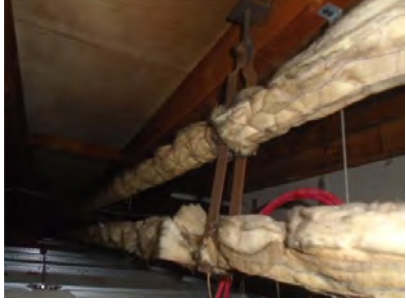
Ref	Status	Sample No.	Location
177	Tested Negative	01436-50-01-05	50 00 Catering Services 001 KitchenGround :
Description Notes Non asbestos textile string to mmmf pipework insulation in ceiling void. Common throughout. Accessed during survey Yes

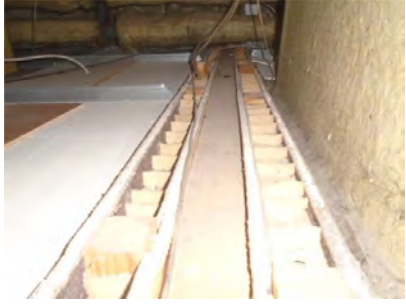
Ref	Status	Sample No.	Location
179	Tested Negative	01436-50-01-07	50 00 Catering Services 001 KitchenGround :
Description Notes Non asbestos (plasterboard) partition wall. Accessed during survey Yes

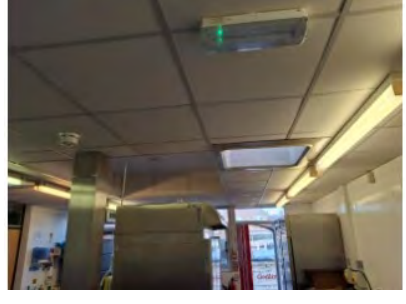
Ref	Status	Sample No.	Location
195	Tested Negative	01436-50-01-08	50 00 Catering Services 001 KitchenGround :
Description Insulating Board Notes Insulating board ceiling tiles. Accessed during survey Yes

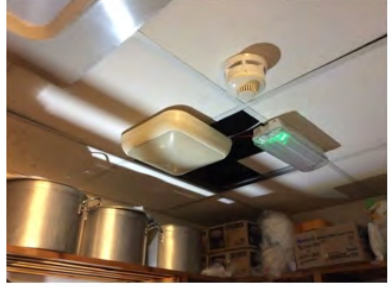
Ref	Status	Sample No.	Location
192	Tested Negative	01436-50-02-04	50 00 Catering Services 002 KitchenGround :
<p>Description Insulating Board</p> <p>Notes Insulating board ceiling tiles</p> <p>Accessed during survey Yes</p>

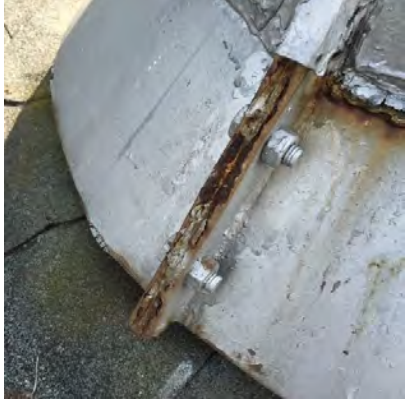
Ref	Sample No.	Location	Extent	Type	Material score	Material risk	Priority	Overall risk
175	01436-01-00-01	01 00 Teaching Block 000 External/ FixturesGround :	4 lin m	Chrysotile	5	Removed	6	Removed

<p>Description Woven Textile</p> <p>Notes External - Roof to Boiler Room 038. Woven seal to chimney joints (presume to all joints)</p> <p>Accessed during survey Yes</p>

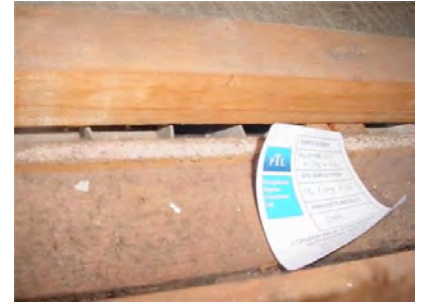
Ref	Sample No.	Location	Extent	Type	Material score	Material risk	Priority	Overall risk
107	01436-01-01-02	01 00 Teaching Block 001 CirculationGround : CEILING VOID	2 LINEAR METRES	Chrysotile	7	Removed	8	Removed

AIB debris on top of the wall to Room 33.

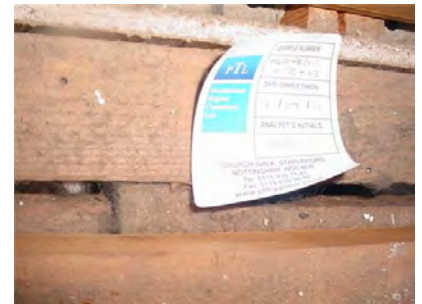
Ref	Sample No.	Location	Extent	Type	Material score	Material risk	Priority	Overall risk
110	01436-01-01-P03	01 00 Teaching Block 001 CirculationGround : CEILING VOID	2 SQUARE METRES	Chrysotile	7	Removed	6	Removed

Insulation board debris within the wall cavity to Room 33 presumed to contain asbestos.

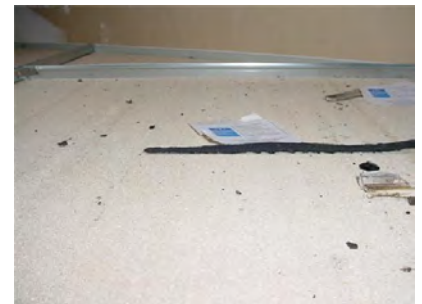
Ref	Sample No.	Location	Extent	Type	Material score	Material risk	Priority	Overall risk
96	01436-01-02-04	01 00 Teaching Block 002 CirculationGround : CEILING VOID	5 SQUARE METRES	Not asbestos		Removed		Removed

Bitumen debris on ceiling tiles.

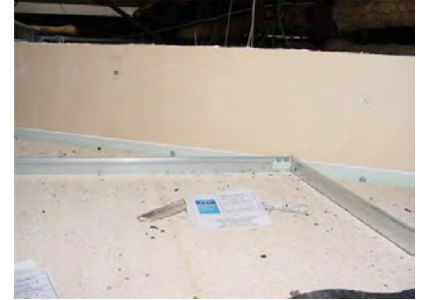
Ref	Sample No.	Location	Extent	Type	Material score	Material risk	Priority	Overall risk
97	01436-01-02-05	01 00 Teaching Block 002 CirculationGround : CEILING VOID	5 SQUARE METRES	Not asbestos		Removed		Removed

Mastic debris on top of the ceiling tiles.

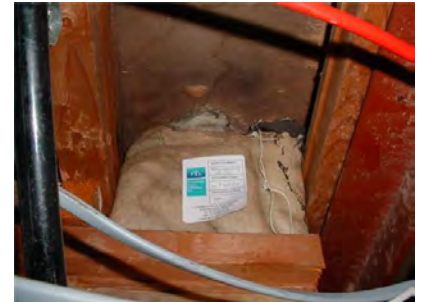
Ref	Sample No.	Location	Extent	Type	Material score	Material risk	Priority	Overall risk
103	01436-01-02-06	01 00 Teaching Block 002 CirculationGround : CEILING VOID	8 SQUARE METRES	Chrysotile	6	Removed	7	Removed

Textile rope to firebreak.

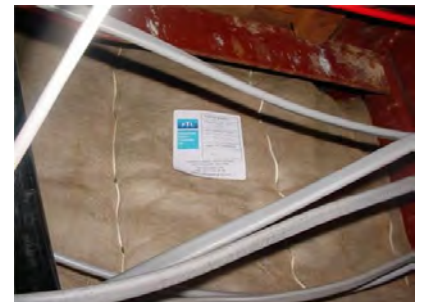
Ref	Sample No.	Location	Extent	Type	Material score	Material risk	Priority	Overall risk
99	01436-01-02-P09	01 00 Teaching Block 002 CirculationGround : CEILING VOID	10 SQUARE METRES	Chrysotile	7	Removed	7	Removed

Textile rope to the fire break within the ceiling void.

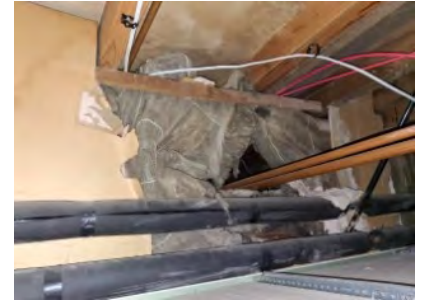
Ref	Sample No.	Location	Extent	Type	Material score	Material risk	Priority	Overall risk
202	01436-01-10-SP01	01 00 Teaching Block 010 ClassroomGround :	12m2	Chrysotile	8	Removed	4	Removed

Woven string to fibreglass firebreaks some behind plasterboard firebreaks to Cloakroom and toilets.

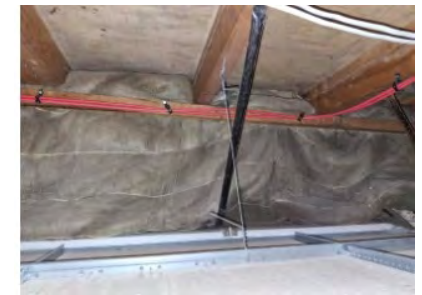
Ref	Sample No.	Location	Extent	Type	Material score	Material risk	Priority	Overall risk
203	01436-01-12-SP01	01 00 Teaching Block 012 CloakroomGround :	12m2	Chrysotile	8	Removed	4	Removed

Woven string to fibreglass firebreaks some behind plasterboard firebreaks.

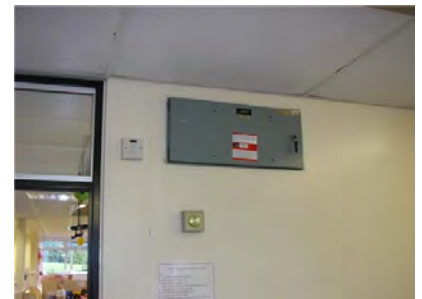
Ref	Sample No.	Location	Extent	Type	Material score	Material risk	Priority	Overall risk
89	01436-01-23-P01	01 00 Teaching Block 023 ClassroomGround : NURSERY	1 BOX	Crocidolite	8	Removed	3	Removed

WALL MOUNTED DISTRIBUTION BOX

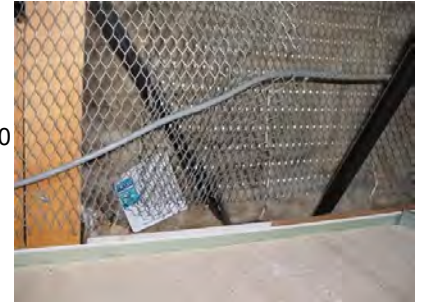
Ref	Sample No.	Location	Extent	Type	Material score	Material risk	Priority	Overall risk
85	01436-01-31-11P	01 00 Teaching Block 032 OfficeGround : CEILING VOID	3 LINEAR METRES	Chrysotile	7	Removed	7	Removed

Rope textiles to fire break presumed to contain asbestos as previous sample no. 01436-01-30-10 within the ceiling void.

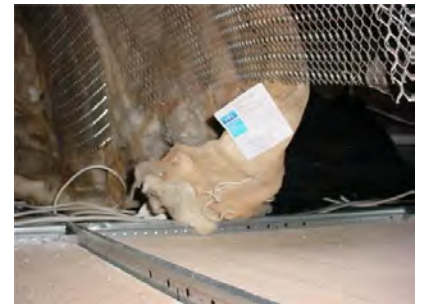
Ref	Sample No.	Location	Extent	Type	Material score	Material risk	Priority	Overall risk
101	01436-01-32-04	01 00 Teaching Block 032 OfficeGround : CEILING VOID	2 SQUARE METRES	Chrysotile	7	Removed	7	Removed

Rope reinforcing to redundant glass fibre fire break within the ceiling void.

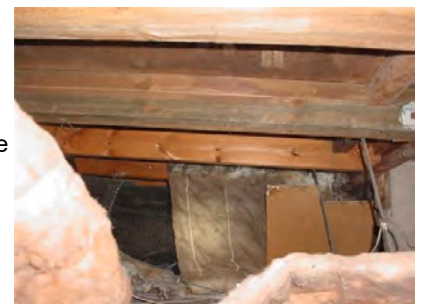
Ref	Sample No.	Location	Extent	Type	Material score	Material risk	Priority	Overall risk
82	01436-01-32-12P	01 00 Teaching Block 032 OfficeGround : CEILING VOID	9 LINEAR METRES	Chrysotile	7	Removed	7	Removed

Rope textile to firebreak within the ceiling void presumed to contain asbestos as previous sample no. 01436-01-30-120.

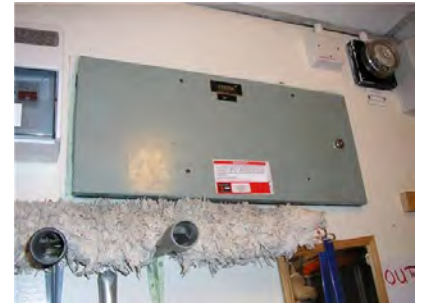
Ref	Sample No.	Location	Extent	Type	Material score	Material risk	Priority	Overall risk
77	01436-01-33-P01	01 00 Teaching Block 032 OfficeGround : CARETAKER'S ROOM	1 BOX	Crocidolite	8	Removed	3	Removed

WALL MOUNTED DISTRIBUTION BOX

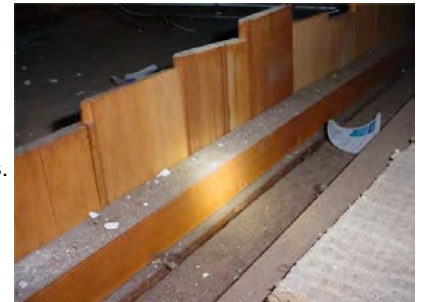
Ref	Sample No.	Location	Extent	Type	Material score	Material risk	Priority	Overall risk
80	01436-01-33-P04	01 00 Teaching Block 032 OfficeGround : CEILING VOID	2 LINEAR METRES	Chrysotile	7	Removed	3	Removed

Insulation board debris on top of the wall to Room 01 within the ceiling void presumed to contain asbestos as previous sample no. 01436-01-01-02. Limited access gained within the wall cavities.

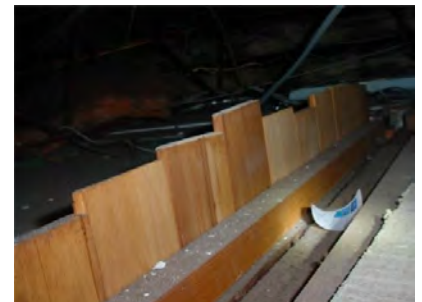
Ref	Sample No.	Location	Extent	Type	Material score	Material risk	Priority	Overall risk
81	01436-01-33-SP05	01 00 Teaching Block 032 OfficeGround : CEILINV VOID	2 SQUARE METRES	Chrysotile	7	Removed	3	Removed

Insulation board debris within the wall cavity to Room 01 presumed to contain asbestos as previous sample no. 01436-01-01-02. Limited access gained within the wall cavities.

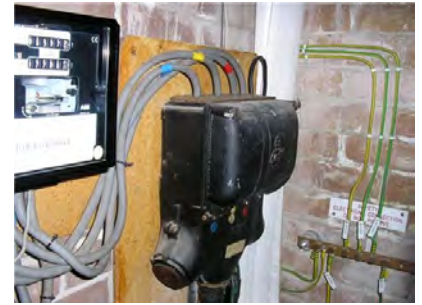
Ref	Sample No.	Location	Extent	Type	Material score	Material risk	Priority	Overall risk
75	01436-01-36-P01	01 00 Teaching Block 036 MeterGround : ELECTRIC ROOM	3 BOXES	Crocidolite	8	Removed	2	Removed

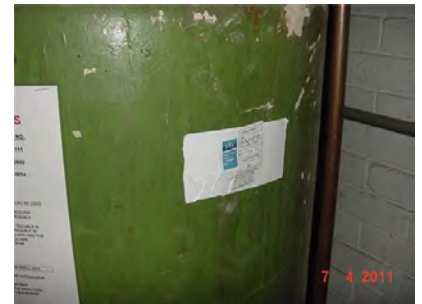
Ref	Sample No.	Location	Extent	Type	Material score	Material risk	Priority	Overall risk
71	01436-01-38-01	01 00 Teaching Block 038 Boiler RoomGround :	4 SQUARE METRES	Not asbestos		Removed		Removed

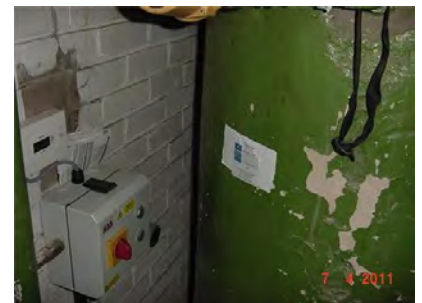
Ref	Sample No.	Location	Extent	Type	Material score	Material risk	Priority	Overall risk
72	01436-01-38-02	01 00 Teaching Block 038 Boiler RoomGround :	4 SQUARE METRES	Not asbestos		Removed		Removed

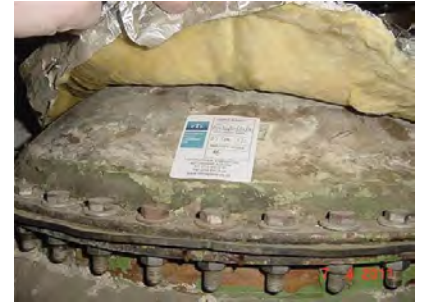
Ref	Sample No.	Location	Extent	Type	Material score	Material risk	Priority	Overall risk
67	01436-01-38-06	01 00 Teaching Block 038 Boiler RoomGround :	2 SQUARE METRES	Not asbestos		Removed		Removed

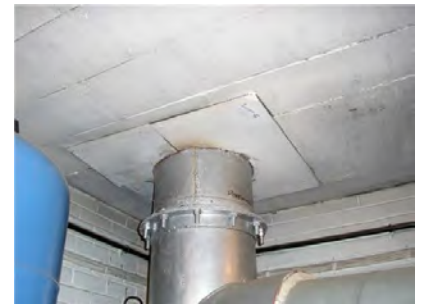
Ref	Sample No.	Location	Extent	Type	Material score	Material risk	Priority	Overall risk
68	01436-01-38-10	01 00 Teaching Block 038 Boiler RoomGround : BOILER ROOM CEILING	1 SQ M	Amphibole ex. Crocidolite	7	Removed	5	Removed

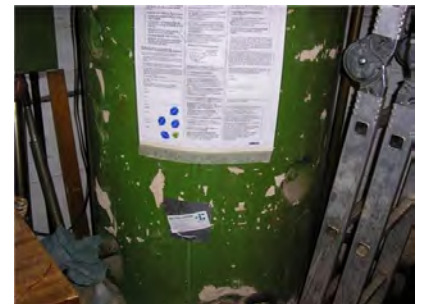
Ref	Sample No.	Location	Extent	Type	Material score	Material risk	Priority	Overall risk
69	01436-01-38-11	01 00 Teaching Block 038 Boiler RoomGround : BOILER ROOM CALORIFIER	6 SQ M	Not asbestos		Removed		Removed

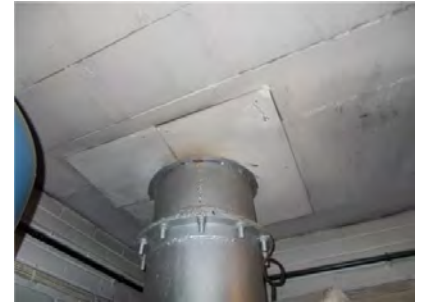
Ref	Sample No.	Location	Extent	Type	Material score	Material risk	Priority	Overall risk
119	01436-01-38-19	01 00 Teaching Block 038 Boiler RoomGround :	<1m2	Amphibole ex. Crocidolite	8	Removed	2	Removed

Panel surround to flue/soffit

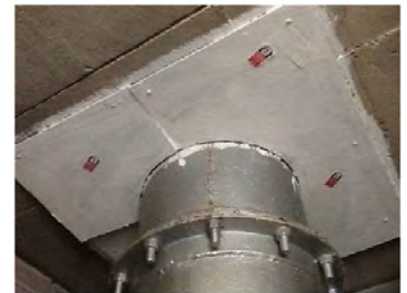
Ref	Sample No.	Location	Extent	Type	Material score	Material risk	Priority	Overall risk
184	01436-01-38-20	01 00 Teaching Block 038 Boiler RoomGround :	1m2	Amphibole ex. Crocidolite	5	Removed	6	Removed

Insulating Board panel to soffit around chimney penetration

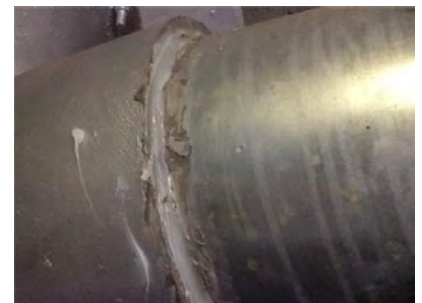
Ref	Sample No.	Location	Extent	Type	Material score	Material risk	Priority	Overall risk
169	01436-01-38-21	01 00 Teaching Block 038 Boiler RoomGround :	<1 lin m	Not asbestos		Removed		Removed

Putty to joint on flue pipe.

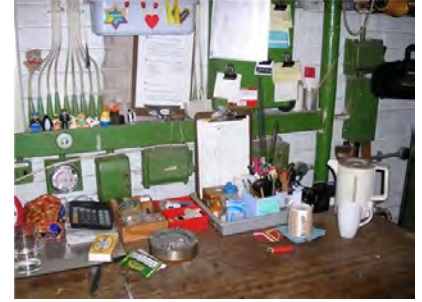
Ref	Sample No.	Location	Extent	Type	Material score	Material risk	Priority	Overall risk
70	01436-01-38-P01	01 00 Teaching Block 038 Boiler Room Ground : BOILER ROOM	5 BOXES	Crocidolite	8	Removed	3	Removed

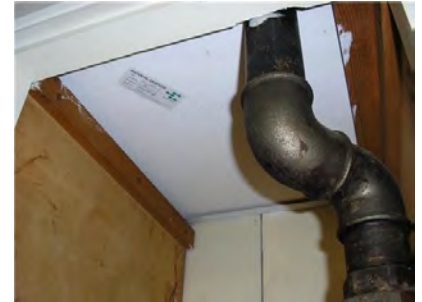
Ref	Sample No.	Location	Extent	Type	Material score	Material risk	Priority	Overall risk
61	01436-50-01-01	50 00 Catering Services 001 KitchenGround : KITCHEN CUPBOARD	1 SQ M	Crocidolite	7	Removed	2	Removed

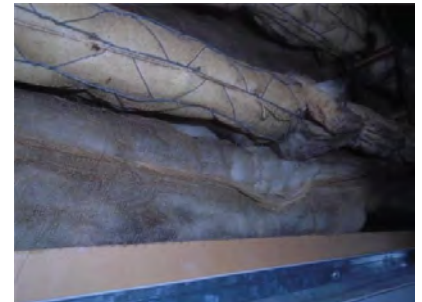
Ref	Sample No.	Location	Extent	Type	Material score	Material risk	Priority	Overall risk
178	01436-50-01-06	50 00 Catering Services 001 KitchenGround :	> 10 m <= 50 m linear	Chrysotile	6	Removed	1	Removed

Asbestos textile string to mmmf firebreak.

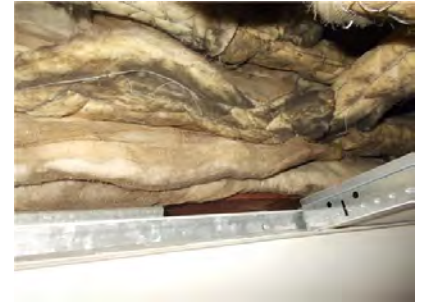
Ref	Sample No.	Location	Extent	Type	Material score	Material risk	Priority	Overall risk
160	01436-50-02-03	50 00 Catering Services 002 KitchenGround :	N/Q	Chrysotile	6	Removed	3	Removed

String to fibreglass quilt firebreaks

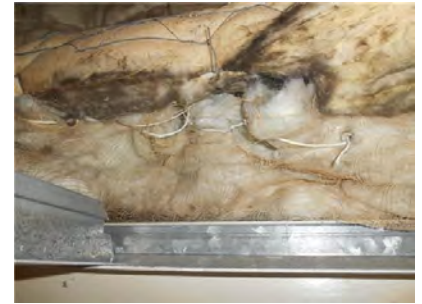
Ref	Sample No.	Location	Extent	Type	Material score	Material risk	Priority	Overall risk
167	01436-50-03-05	50 00 Catering Services 003 KitchenGround :	<1m2	Chrysotile	4	Removed	1	Removed

String to pipework insulation within ceiling void

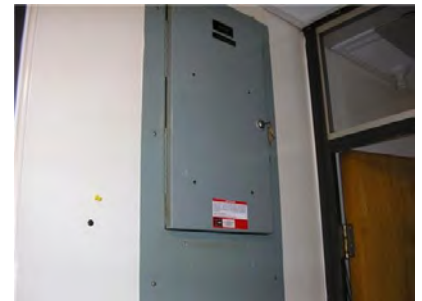
Ref	Sample No.	Location	Extent	Type	Material score	Material risk	Priority	Overall risk
60	01436-50-03-P01	50 00 Catering Services 003 KitchenGround : OFFICE	1 BOX	Crocidolite	8	Removed	3	Removed

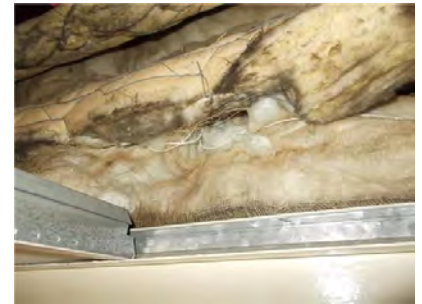
Ref	Sample No.	Location	Extent	Type	Material score	Material risk	Priority	Overall risk
163	01436-50-03-SP04	50 00 Catering Services 003 KitchenGround :	N/Q	Chrysotile	6	Removed	3	Removed

String to fibreglass quilt firebreaks

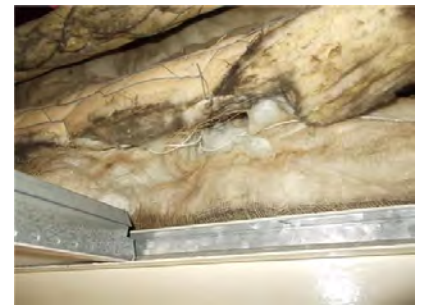
Ref	Sample No.	Location	Extent	Type	Material score	Material risk	Priority	Overall risk
166	01436-50-04-SP03	50 00 Catering Services 004 Staff WCGround :	N/Q	Chrysotile	6	Removed	3	Removed

String to fibreglass quilt firebreaks
